**FIVE-YEAR REVIEW REPORT FOR
KERR-MCGEE CHEMICAL CORPORATION SUPERFUND SITE
CARIBOU COUNTY, IDAHO**

Prepared by:
CH2MHILL.
Boise, Idaho

Prepared for:
U.S. Environmental Protection Agency
Region 10
Seattle, Washington

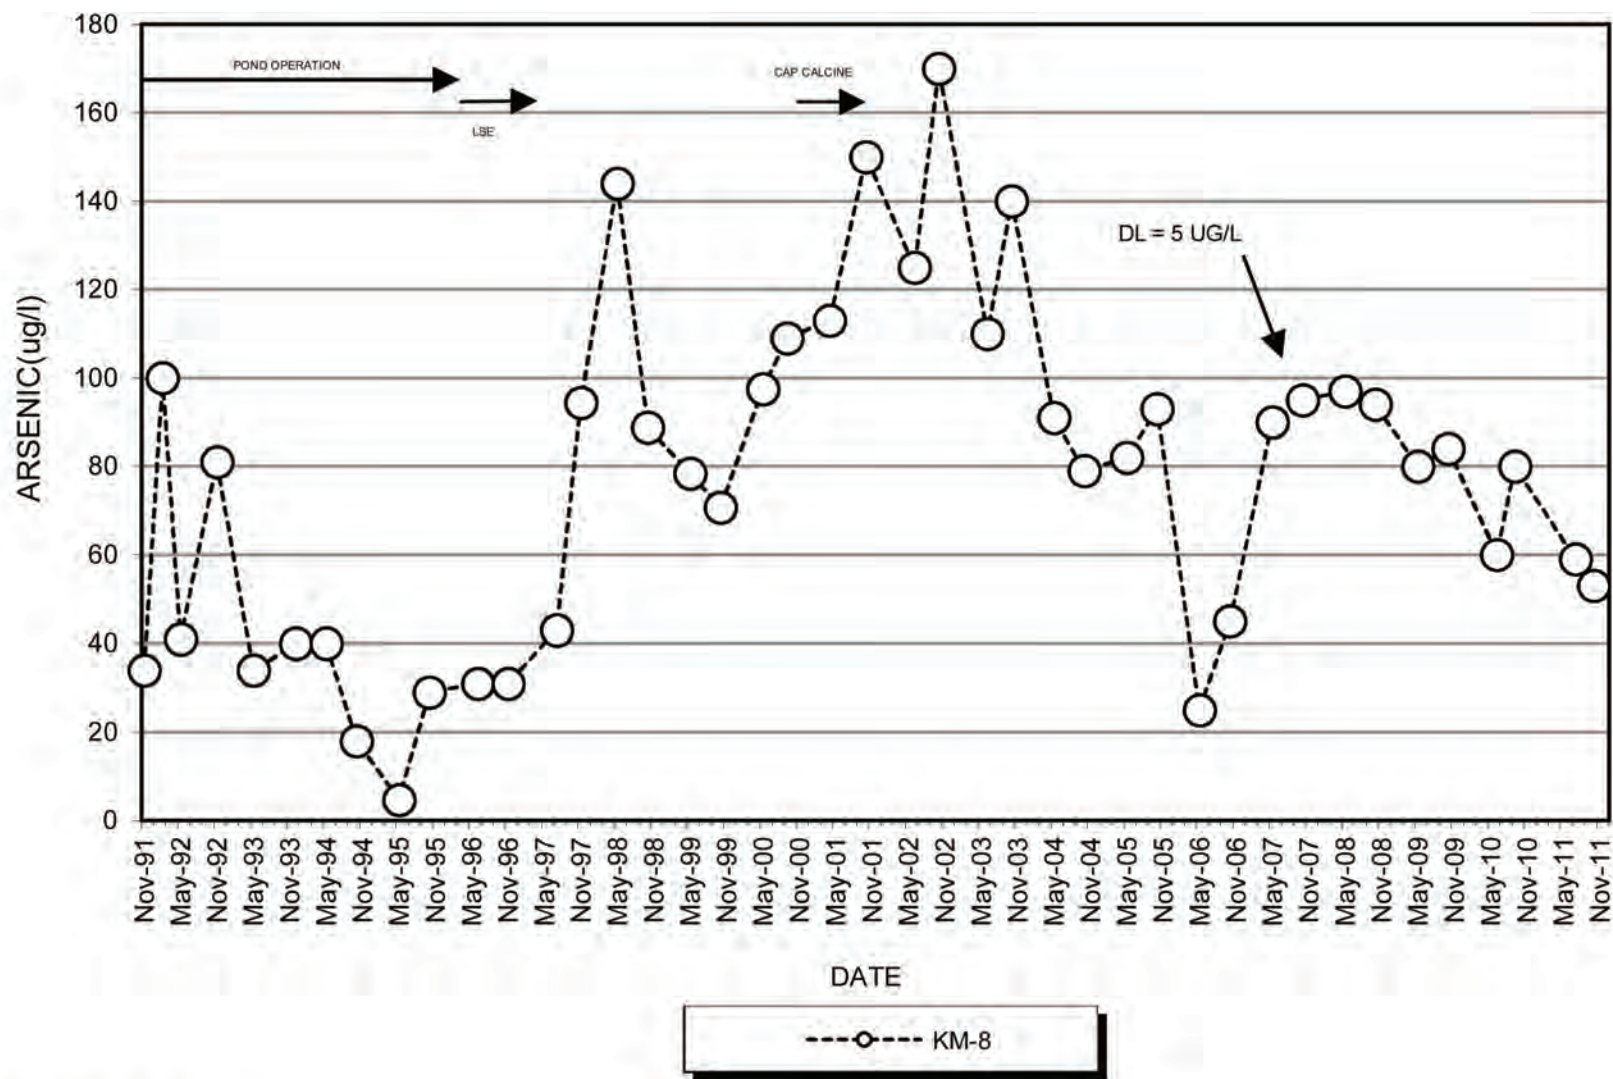
FIGURE 5
 Arsenic vs. Time
 Well KM-8 Near Former S-X Pond
 Kerr-McGee 2012 Five Year Review

As shown in Figure 5, arsenic concentrations at Well KM-8 (currently 53 µg/L) remain well above the MCL of 10 µg/L. A decreasing arsenic trend in Well KM-8 was observed between 2008 and 2011. Arsenic concentrations in wells located offsite have been stable since 2007, as shown in Figure 6. Arsenic concentrations at these offsite monitoring wells are below the MCL of 10 µg/L.

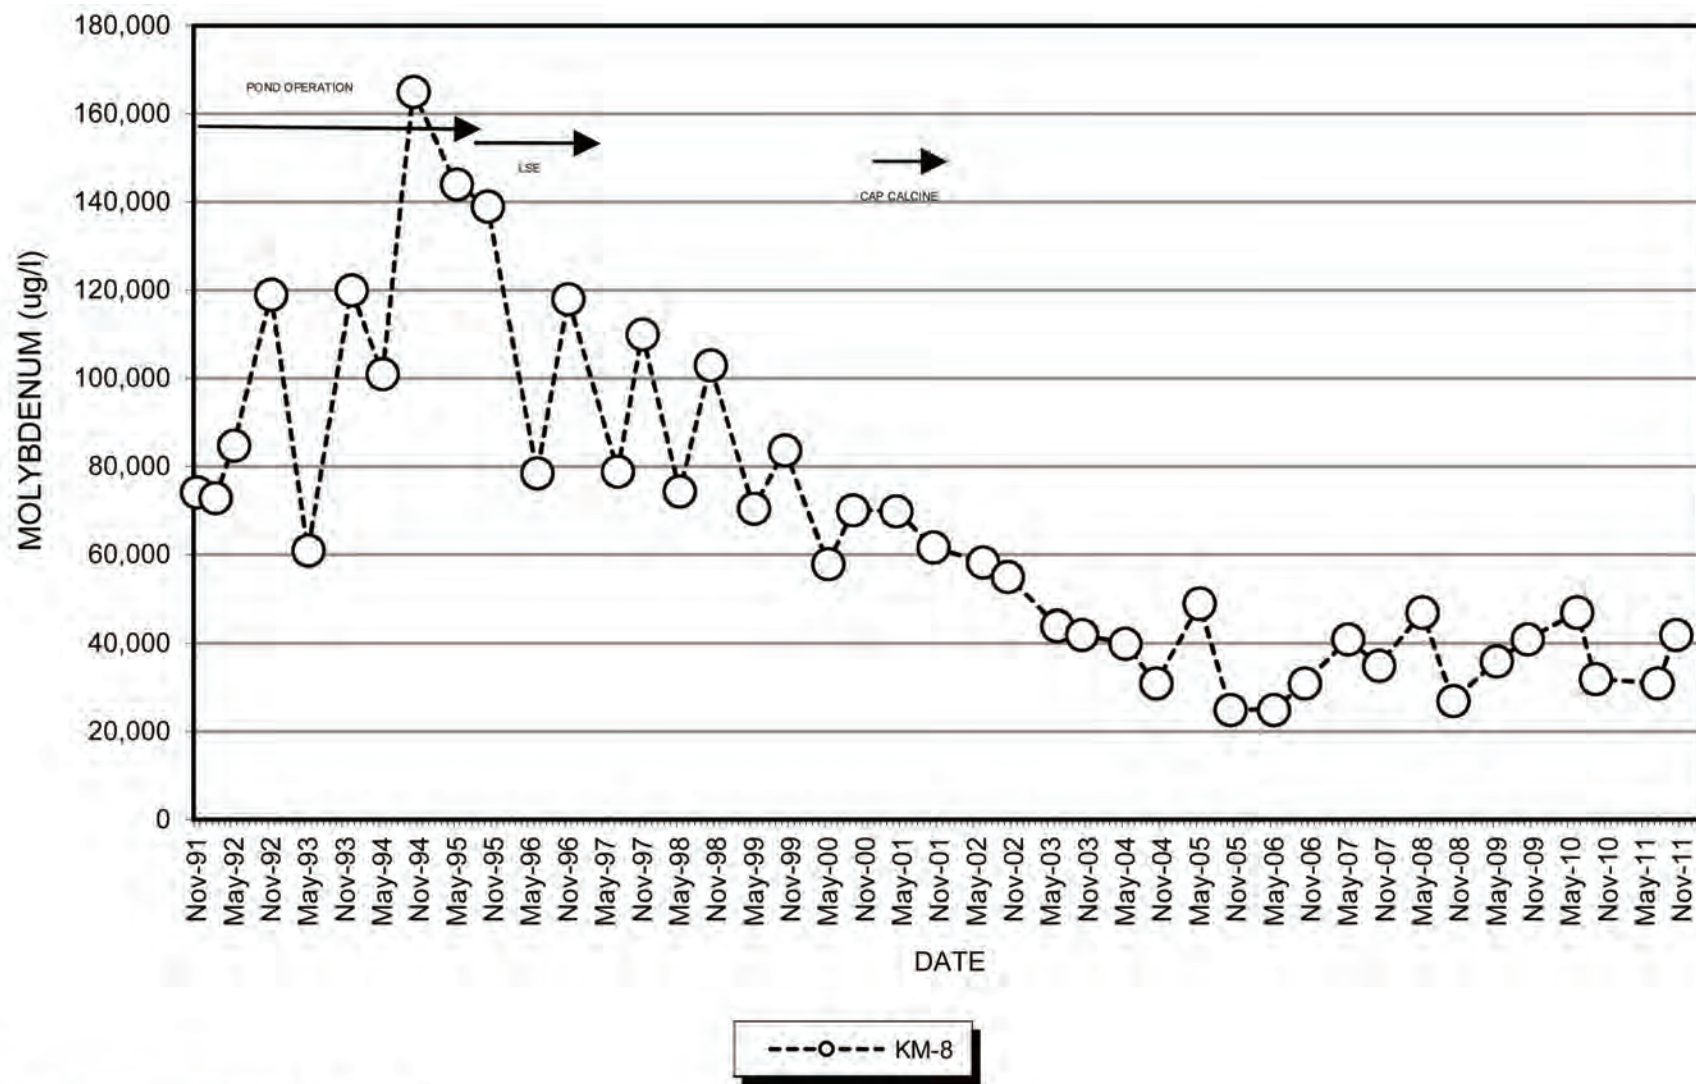
FIGURE 13
Molybdenum vs. Time
Well KM-8 Near Former S-X Pond
Kerr-McGee 2012 Five Year Review

Molybdenum concentrations observed in Figure 13 for Well KM-8 show a decreasing trend from 1995 to 2005. Concentrations appear to be variable from 2005 to present with no overall trend. However, concentrations at Well KM-8 (currently 42,000 µg/L) remain the highest at the Site. As shown in Figure 14, concentrations of molybdenum have shown a decreasing trend at the offsite wells since 2003, although the decreasing trend has flattened from 2003 to the present.

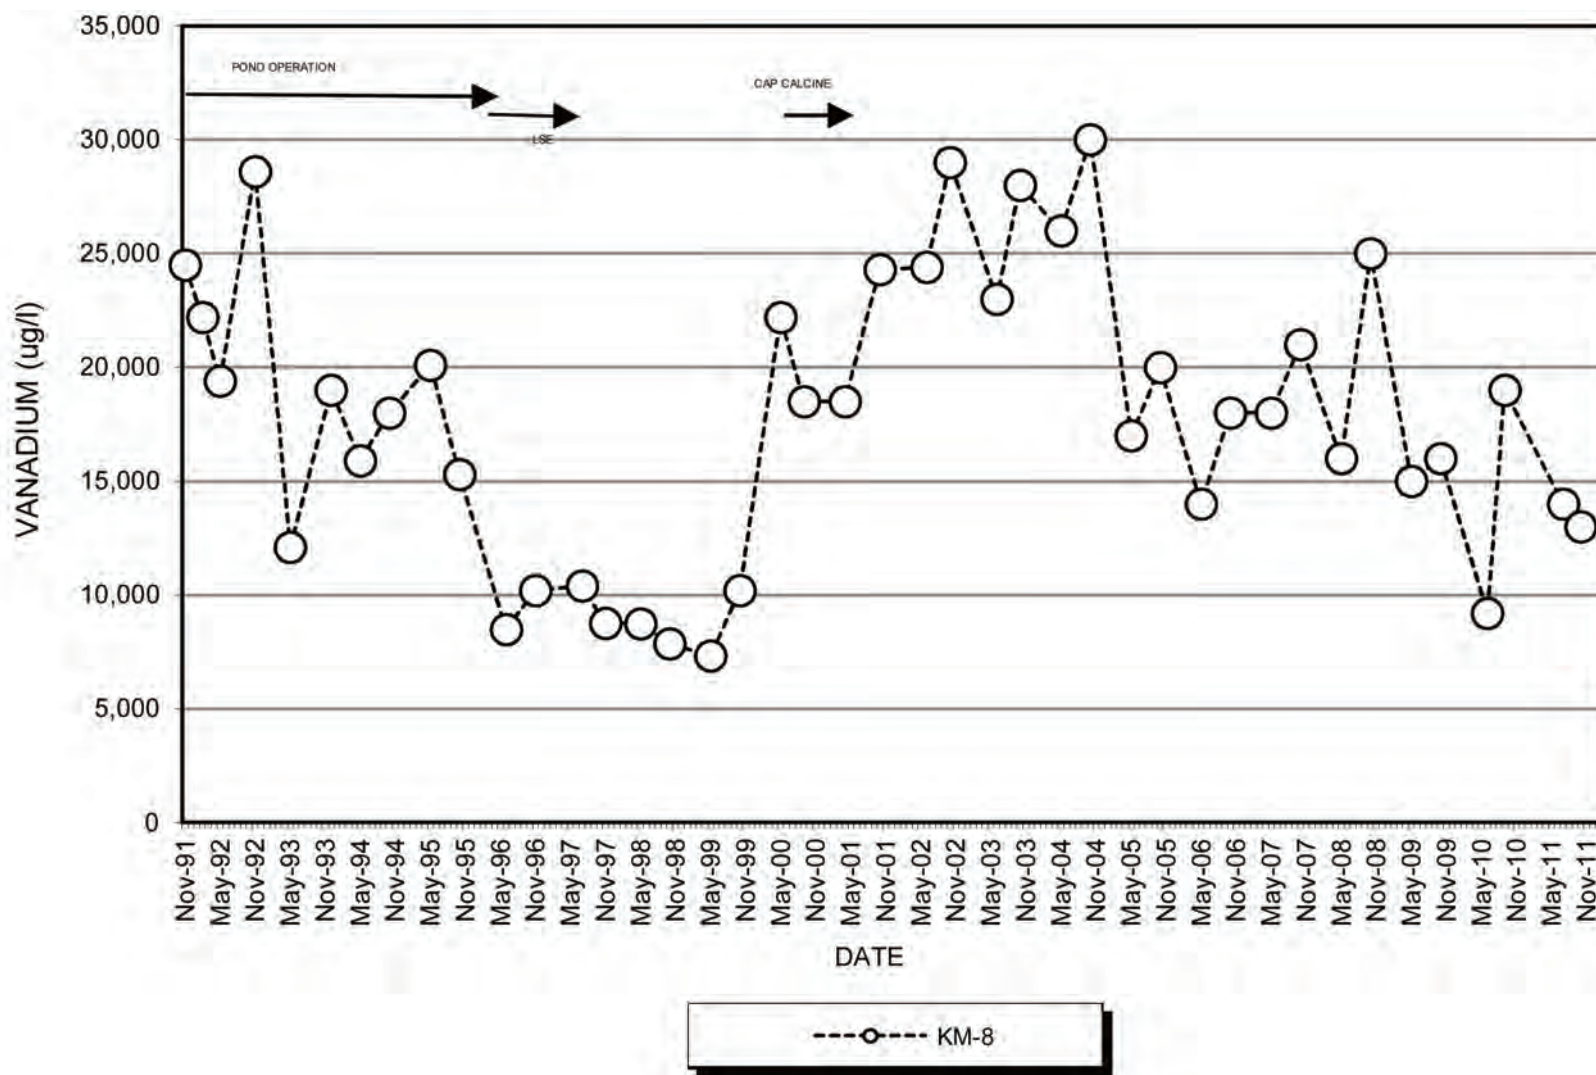
FIGURE 17
Vanadium vs. Time
Well KM-8 Near Former S-X Pond
Kerr-McGee 2012 Five Year Review

Vanadium concentrations at Well KM-8 have been highly variable throughout the period of study (Figure 17). A decrease in vanadium concentrations was observed from 1991 to 1995, a flattened trend from 1995 to 1999, an increasing trend from 1999 to 2004, and finally a decreasing trend from 2004 to the present. Concentrations of vanadium at Well KM-8 (currently 13,000 µg/L) remain the highest at the site and exceed the risk-based groundwater performance standard of 180 µg/L. Concentrations at the offsite wells remain above the risk-based groundwater performance standard, with the exception of Well KM-17 (Figure 18). Vanadium concentration trends at these offsite monitoring wells exhibited a decreasing trend.

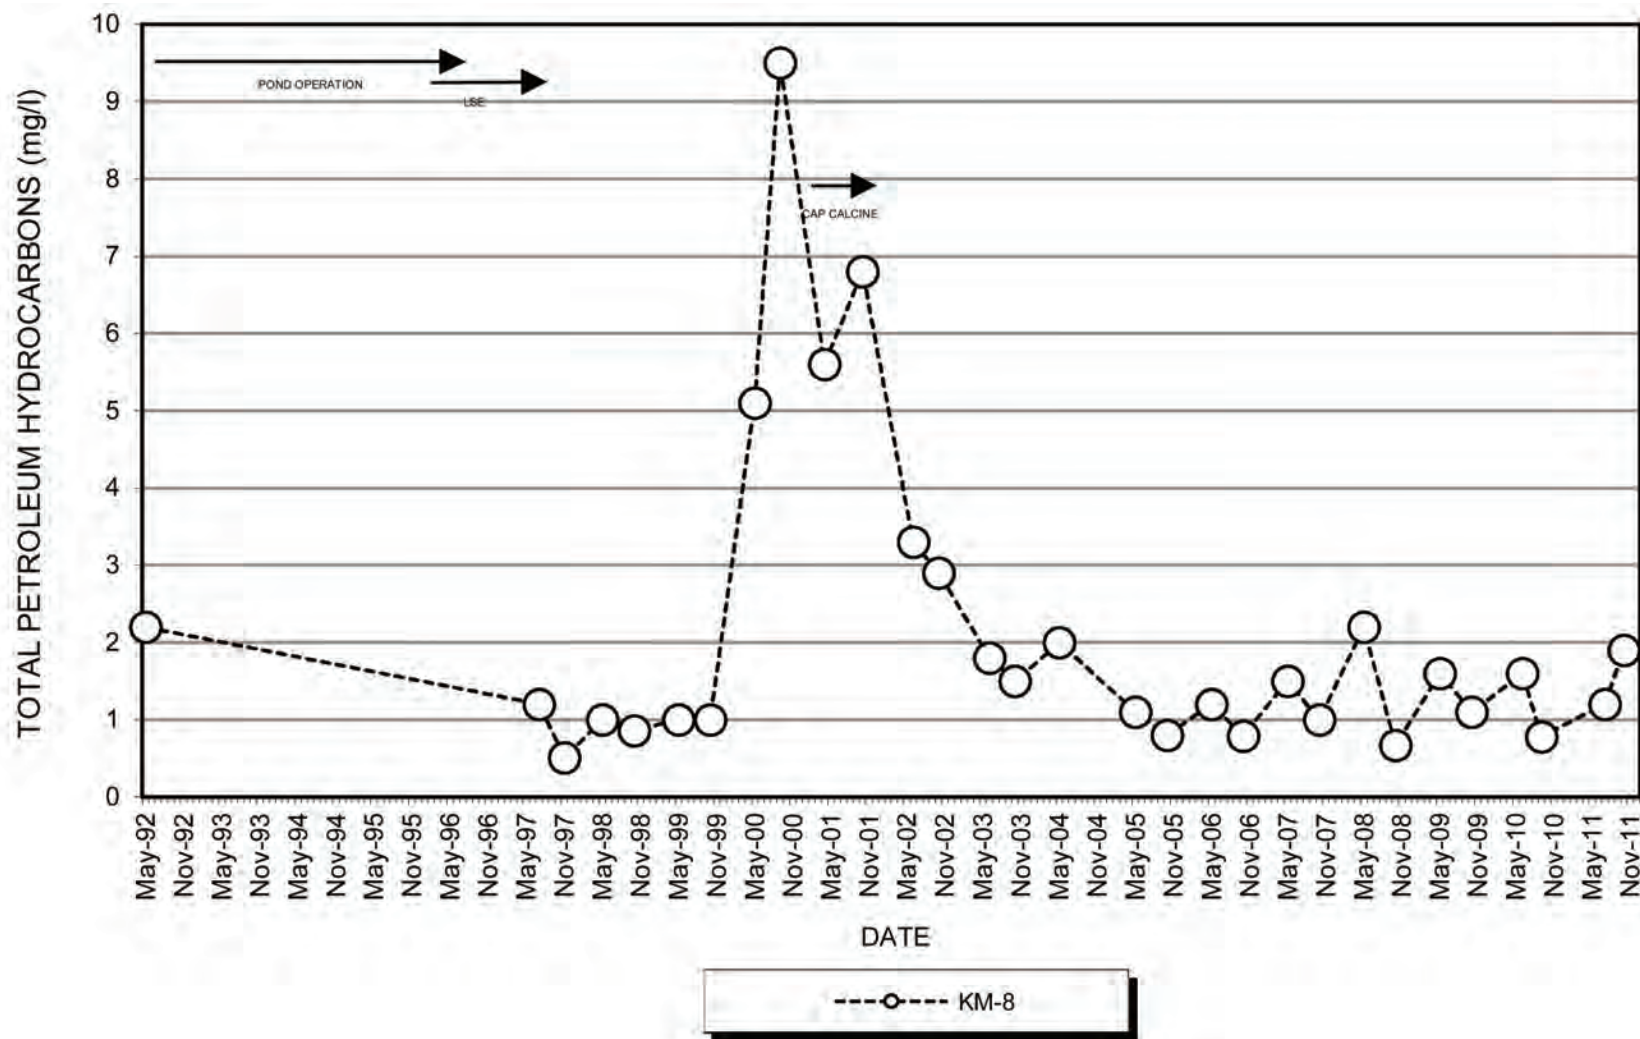
FIGURE 19
 Total Petroleum Hydrocarbons vs. Time
 Well KM-8 Near Former S-X Pond
 Kerr-McGee 2012 Five Year Review

Well KM-8 is the only well that is routinely sampled for TPH. Concentrations remained relatively stable from 1997 to 2000 with a significant increase from 2000 to 2002 (Figure 19). Concentrations of TPH from 2002 to the present are similar to those concentrations observed prior to 2000 and exhibit a relatively stable trend—remaining above the risk-based groundwater performance standard of 0.73 mg/L (current concentration 1.9 mg/L).

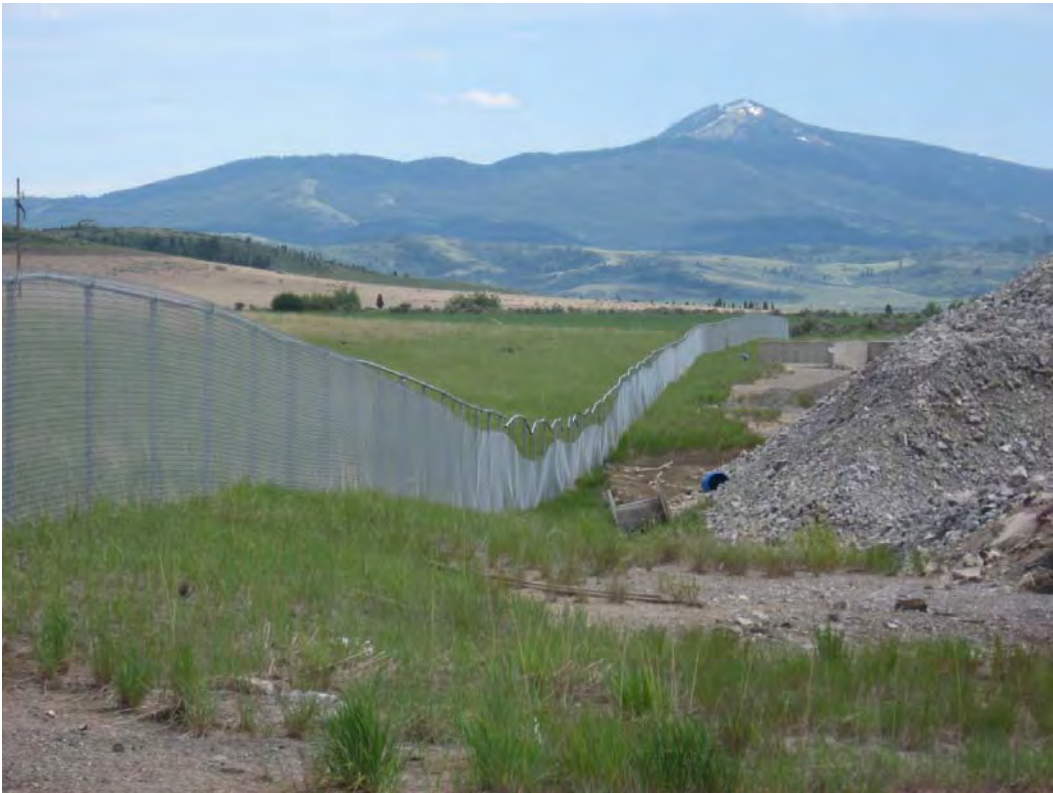
The site inspection was limited to the facility and offsite well locations. The only significant finding was the fencing surrounding the caps was observed to be compromised in multiple sections. A Site Investigation Checklist is included in Appendix C and provides additional details regarding the condition and performance of the remedy. Photographs from the site visit are included in Appendix D.

In addition, based on observations made during the June 12, 2012 site visit, the fencing surrounding the landfill and calcine cap will need repairs on multiple sections.

PHOTOGRAPH 4: Calcine Cap Fence line (Facing North)

5. Augment/expand existing groundwater monitoring network and/or perform additional characterization work to better define plumes.
6. Repair identified fence sections located at the landfill and calcine caps.
